Manhole Inspection Summary

Manhole # S43EE_018MH

Insp Date: **3/10/08 10:34 AM**

Location Address: **1700 E BIDDLE ST**

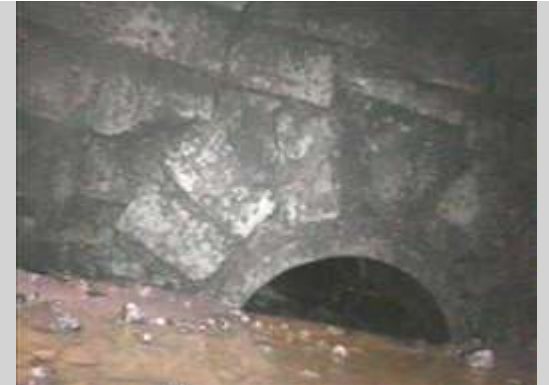
12 O'Clock Outflow

8 in. Circular Gravity Sewer
Pipe Out @ 12 O'Clock

Deposits: ☐ None ☒ **Mud** ☒ **Gravy** ☒ **Debris** ☐ Grease

Silt Depth: **5** (in.) Deposits Extent: **Heavy**
